**State of California  
The Resources Agency  
DEPARTMENT OF WATER RESOURCES  
DIVISION OF FLOOD MANAGEMENT**

**2004  
PROJECT STRUCTURE REPORT**

**INSPECTION OF  
FLOOD CONTROL STRUCTURES ON THE  
SACRAMENTO AND SAN JOAQUIN RIVERS  
AND THEIR TRIBUTARIES**

**Prepared By The  
Flood Operations Branch  
Flood Project Inspection Section**

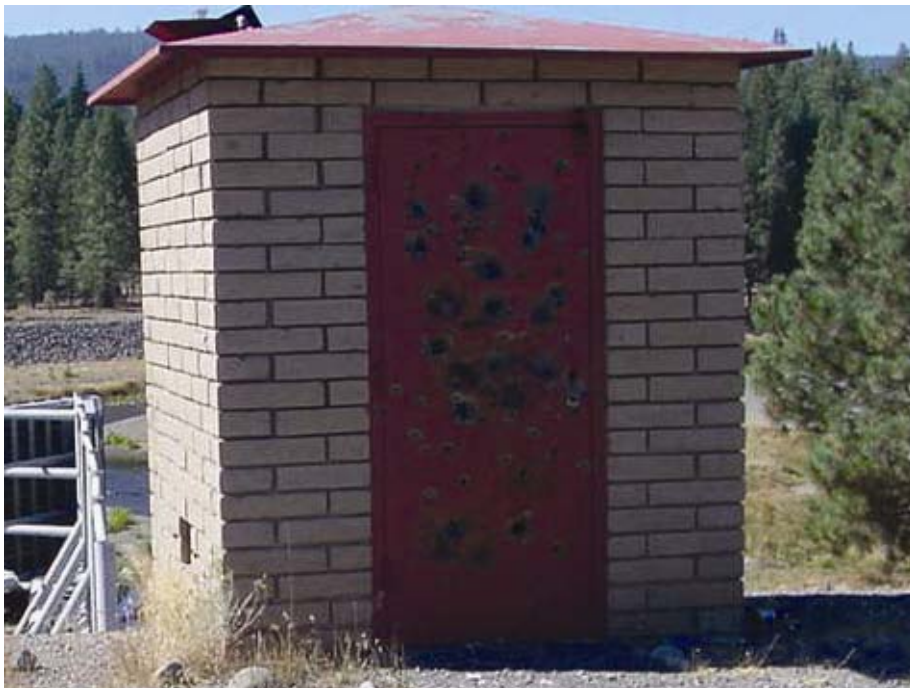
1. Condition of concrete diversion structure.
  - a. Good.
2. Condition of the gauging house and equipment.
  - a. Fair. There are still numerous bullet holes in the door.
3. Condition of the steel trash racks.
  - a. Good.
4. Condition of debris deflection structure.
  - a. Good.
5. Condition of the revetments.
  - a. Good.
6. Accumulation of trash and debris around structure or in the channel.
  - a. Minimal amount of debris around the deflection structure.
7. Vegetation around the structure or in the channel.
  - a. None.
8. Condition of the conduits.
  - a. The center conduit was inspected this year and found to be in good condition. However the separations at the joints between the monoliths have increased.

**The gauging house door is severely damaged, resulting in no access.**

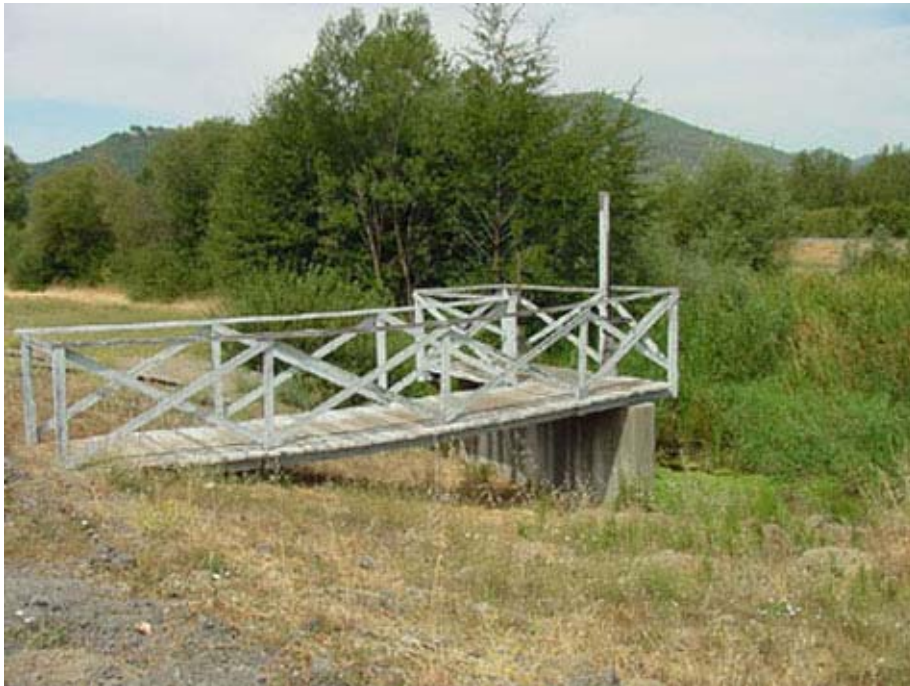
**Growth on upstream side.**

1. Condition of concrete weir structure.
  - a. Good.
2. Condition of the diversion structure and wing walls.
  - a. Good.
3. Condition of the bulkhead.
  - a. Good.
4. Condition of the control gates and mechanism.
  - a. Good.
5. Accumulation of trash and debris around the structures or in the channel.
  - a. Most of the gravel has been removed from the outlet pipes, but has accumulated within 5 feet of the outlet pipes, thus the water could not flow correctly as designed.
  - b. Some gravel and rock needs to be removed on the upstream side.
6. Vegetation around the structures or in the channel.
  - a. A lot of vegetation upstream from the gates needs to be cleared.
  - b. There is dense vegetation in the creek channel, 30 feet downstream of the structure.
7. Comments:
  - a. Remove accumulated rock, dirt, boulders and gravel upstream of weir.
  - b. Good maintenance.

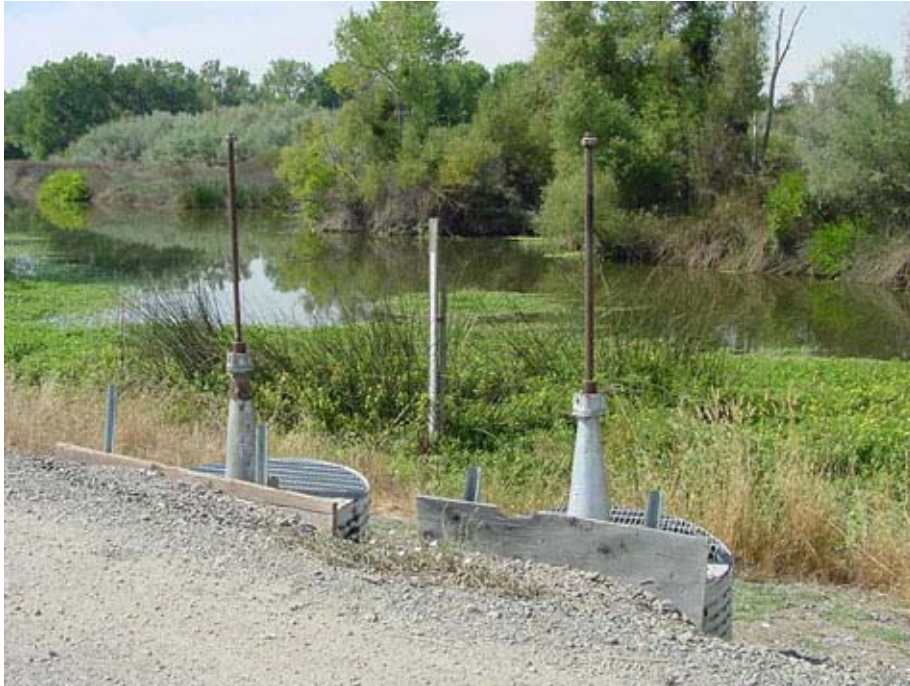
1. **Condition of main pump structure and switchboard house.**
  - a. **Poor. The separation between the top of the surge box and the structure appears to have an eight and one half inch side displacement. The surge box has settled twelve inches since 1962 and is 7.6 feet below the top of the structure. There is approximately a two inch deflection. There have been no changes since last reported.**

**Upstream at the breather pipe and screw gate mechanism.**

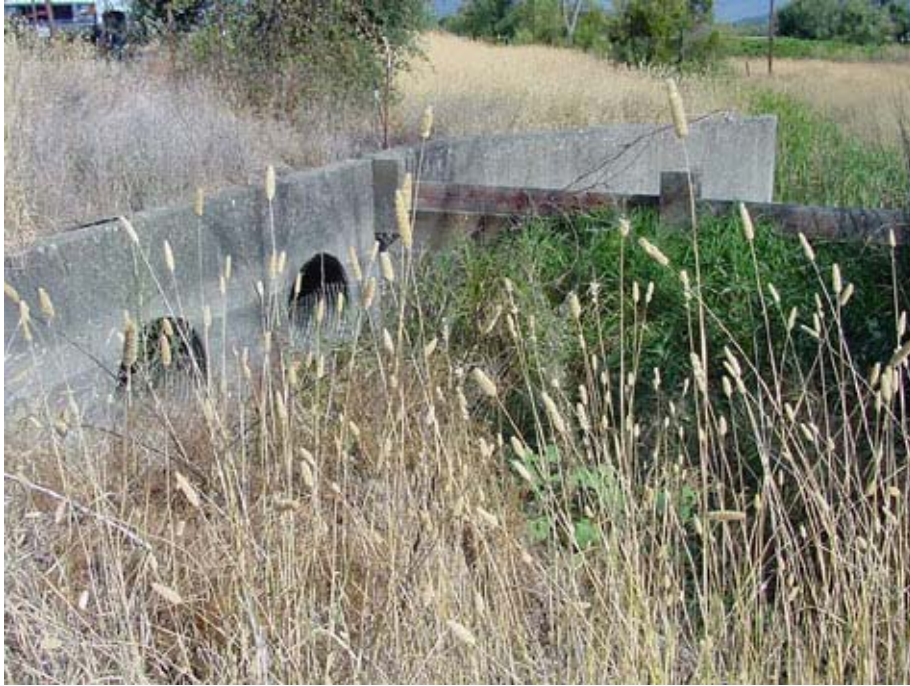
1. Condition of concrete weir structure and stilling basin.
  - a. Good.
2. Condition of drainage structure.
  - a. Good.
3. Condition of the concrete abutments and wing walls.
  - a. There is a displacement between both wing walls and the structure, 2 inches on left wing wall and 2½ inches on the right wing wall. Displacement has been stable for at least 6 years.
4. Condition of the revetment.
  - a. Good.
5. Accumulation of trash and debris around the structure or in the channel.
  - a. None.
6. Vegetation around the structure or in the channel.
  - a. A lot of tule growth and tall grass on south side of abutment.
7. Comments:
  - a. Good maintenance

**The concrete weir and diversion pipe intake.**

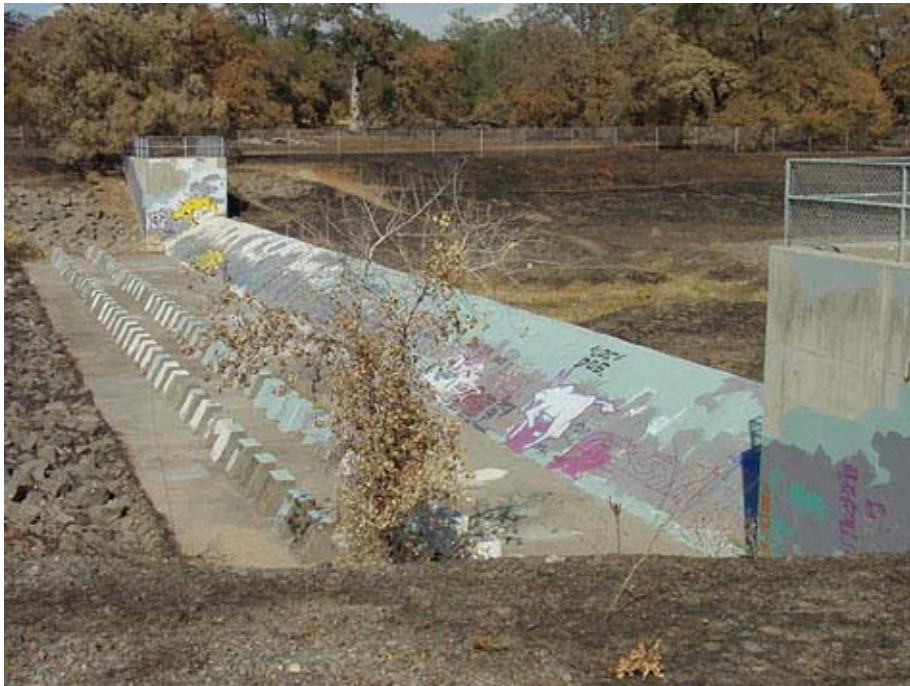
1. Condition of concrete weir structure and stilling basin, and velocity dissipaters.
  - a. There are minor joint separations on the north and south ends of the weir where it contacts the abutments.
  - b. There is minor damage to a few velocity dissipaters.
2. Condition of concrete abutments and wing walls.
  - a. Good.
3. Condition of revetment.
  - a. Good.
4. Accumulation of trash and debris around the structure or in the channel.
  - a. None.
5. Vegetation around structure or in the channel.
  - a. None.
6. Condition of gauging house and equipment.
  - a. Poor.
7. Comments:
  - a. Repair or replace the gauging house.
  - b. Fair maintenance.

**The velocity dissipaters on the downstream side of structure from the left bank.**

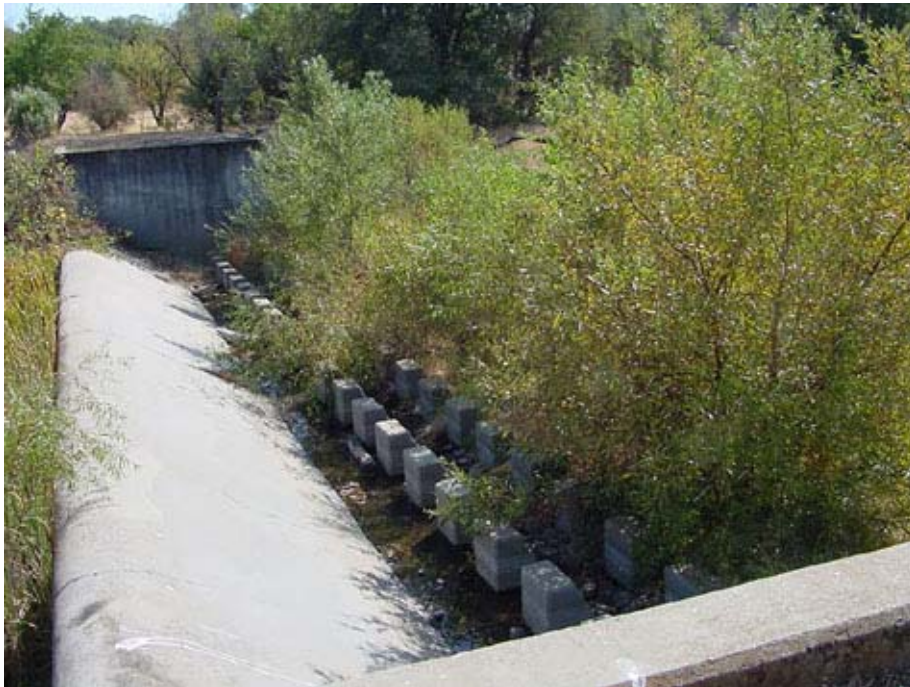
- a. Previously reported separations and displacements are stable.**
- 3. Condition of concrete weir, stilling basin, and velocity dissipaters.**
  - a. Minor cracks in the weir and minor spalling of concrete on the weir invert.**

**The weir and velocity dissipaters.**

- a. Repair the control structure base (downstream side) as soon as possible.**
- b. Continue to monitor joint separation between the control structure and the abutments and repair as needed.**
- c. Remove driftwood and cobbles from dissipaters.**
- d. Remove small trees in front of dissipaters.**
- e. Fair maintenance.**

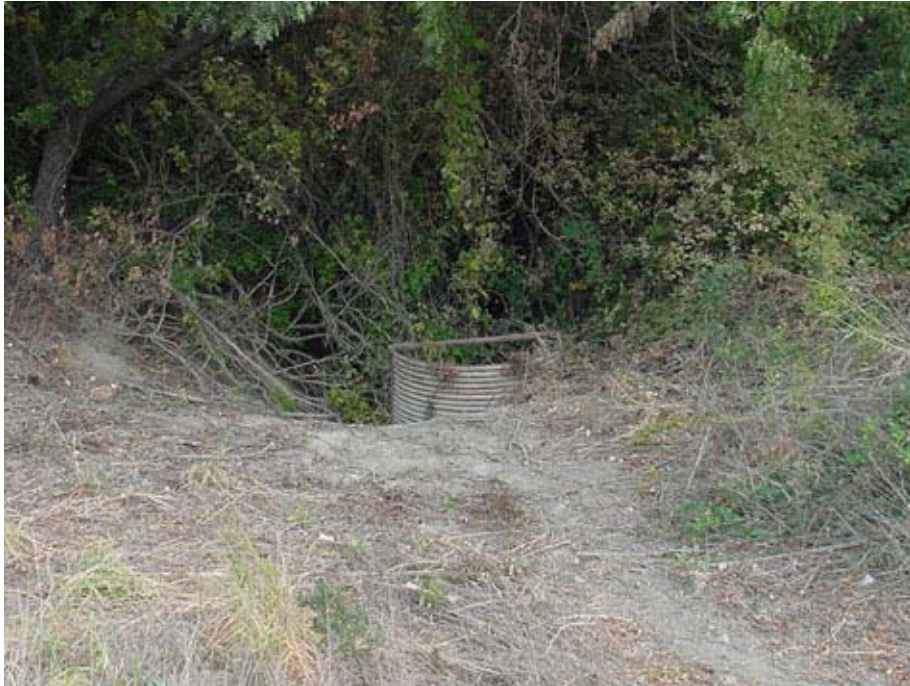
- 1. Condition of the corrugated metal pipe (CMP) drainage structure.**
  - a. Good.**
- 2. Condition of the control gate, mechanisms, and flap gates.**
  - a. Could not properly inspect due to excessive vegetation.**
- 3. Condition of the revetment.**
  - a. Visual inspection was limited due to vegetation.**
- 4. Accumulation of trash and debris around the inlet, in the pipe or in the channel.**
  - a. Minimal.**
- 5. Vegetation around the structure or in the channel.**
  - a. The vegetation immediately around the in-take has been cleared. Growth is so dense that discharge ends of structure cannot be seen.**
- 6. Comments:**
  - a. Remove vegetation from discharge ends of structure. If growth is not removed, the drainage structure could become non-functional.**
  - b. Some maintenance.**
  - c. This structure is rated poor.**

**CMP stand pipe in the center.**

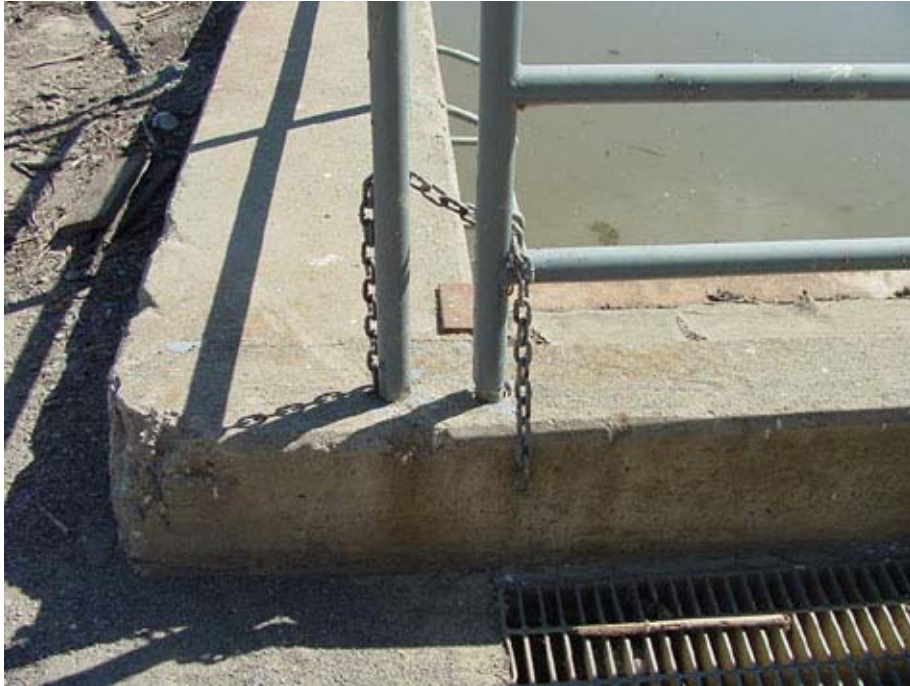
**Railing not locked down, could be easily removed.**

- 1. Condition of the main pump structure.**
  - a. Good.**
- 2. Condition of abutments and wing walls.**
  - a. Good.**
- 3. Condition of pumps and motors.**
  - a. Good.**
- 4. Condition of control gates, mechanisms, and flap gate.**
  - a. Good.**
- 5. Condition of electrical equipment.**
  - a. Good.**
- 6. Condition of trash rack.**
  - a. Good.**
- 7. Condition of revetment.**
  - a. Good.**
- 8. Accumulation of trash and debris in the sump.**
  - a. None.**
- 9. Vegetation in the inlet channel.**
  - a. None.**
- 10. Comments:**
  - a. Tests of pumps, motors and electrical equipment are conducted in October each year.**
  - b. Railing in front of pump gates and on the south side is not locked down, very loose or is missing bolts.**
  - c. Cover exposed electrical wire on south side of wall.**
  - d. Good maintenance.**

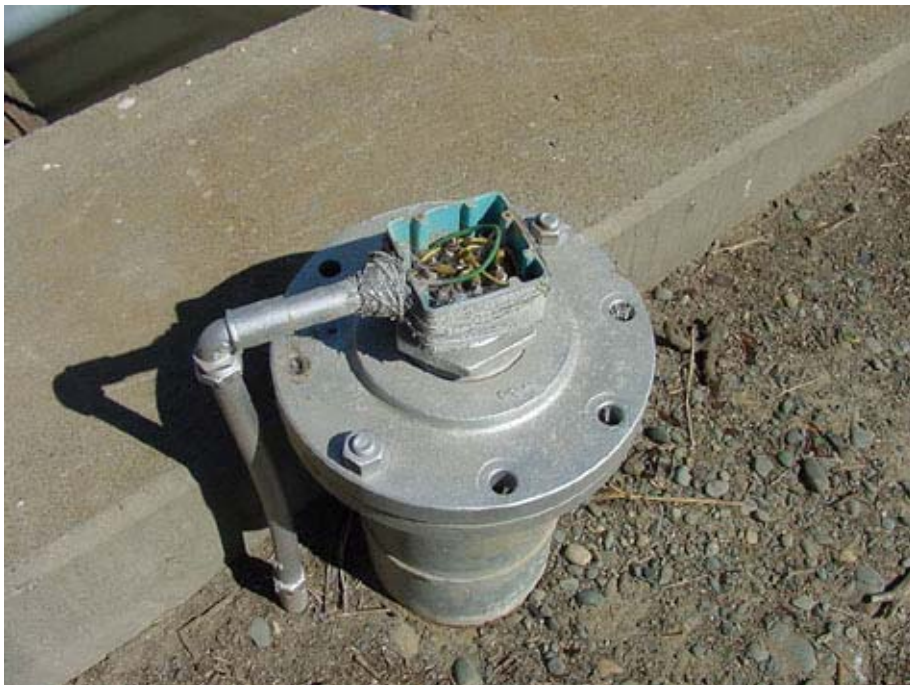
**Electrical wire exposed.**

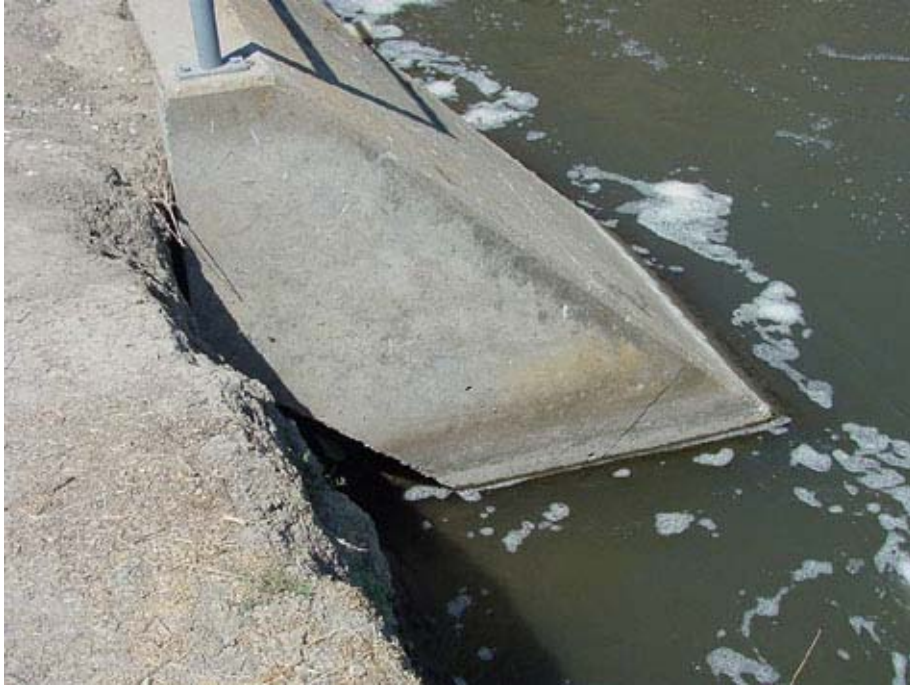
- 1. Condition of main pump structure.**
  - a. Good.**
- 2. Condition of abutments and wing walls.**
  - a. Water is undercutting the south wing wall.**
- 3. Condition of pumps and motors.**
  - a. Good.**
- 4. Condition of control gates, mechanisms, and flap gates.**
  - a. Good.**
- 5. Condition of electrical equipment.**
  - a. Good.**
- 6. Condition of the trash racks.**
  - a. Good.**
- 7. Condition of revetment.**
  - a. Good.**
- 8. Accumulation of trash or debris in the sump.**
  - a. Pump No. 3 has trash and debris in it.**
- 9. Vegetation in the inlet channel.**
  - a. Minimal.**

**Erosion on south wing wall, undercutting the wall.**

- a. Tests of the pumps, motors, and electrical equipment are conducted in October each year.**
- b. Repair bank erosion on south wing wall, undercutting the wall.**
- c. Repair dirt sinking at end of south wall on top, exposing concrete.**
- d. Cover the exposed wire.**
- e. Remove plant growth and debris in pump No. 3.**
- f. Good maintenance.**

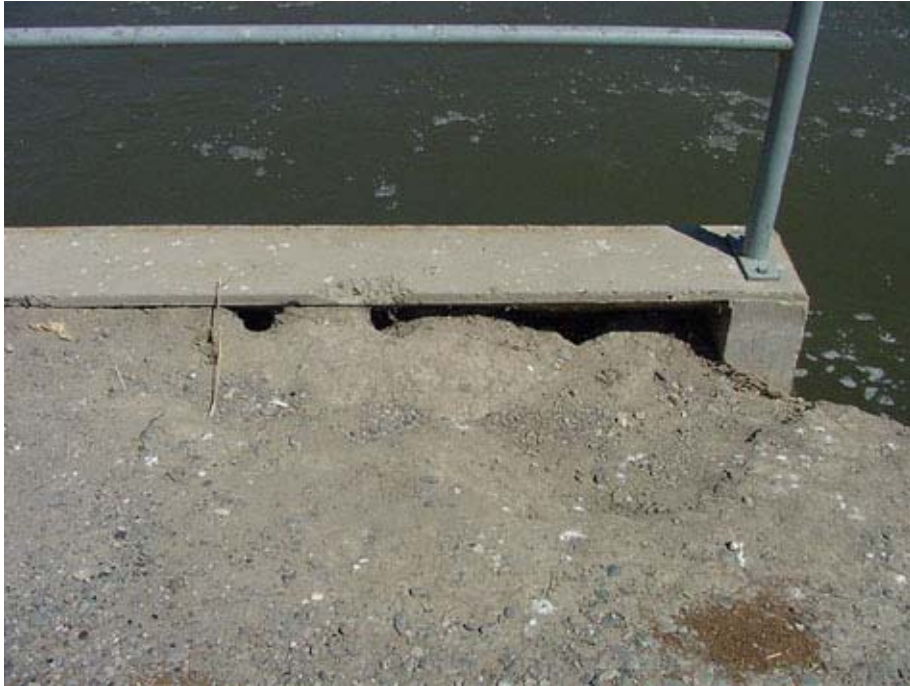
**Dirt sinking at end of south wall on top, exposing concrete.**

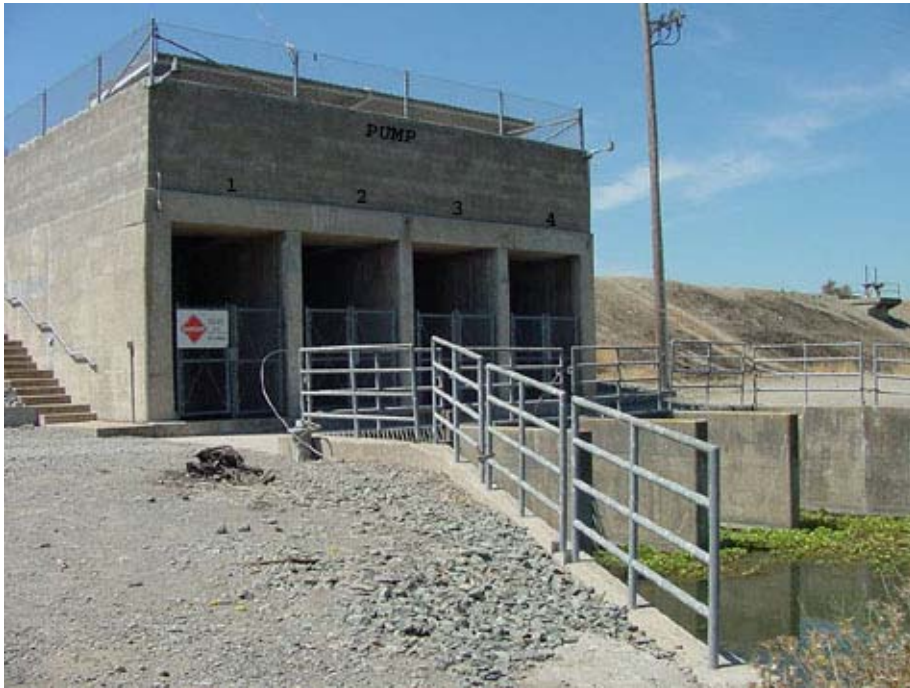
**The inlet side of the pumping plant.  
Pump numbers were inserted onto picture.**

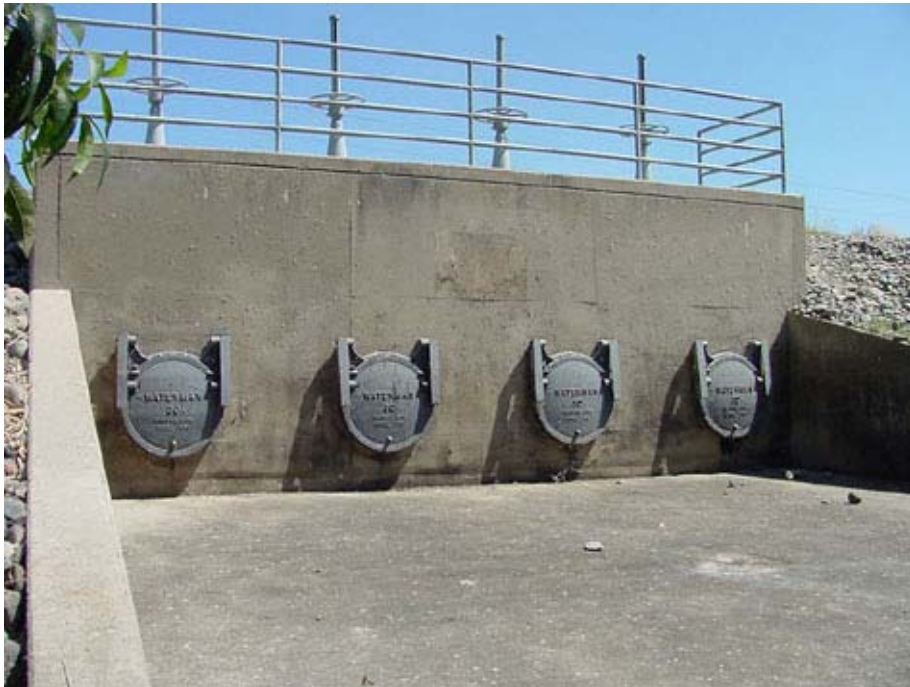
**The discharge side of the pumping plant.**

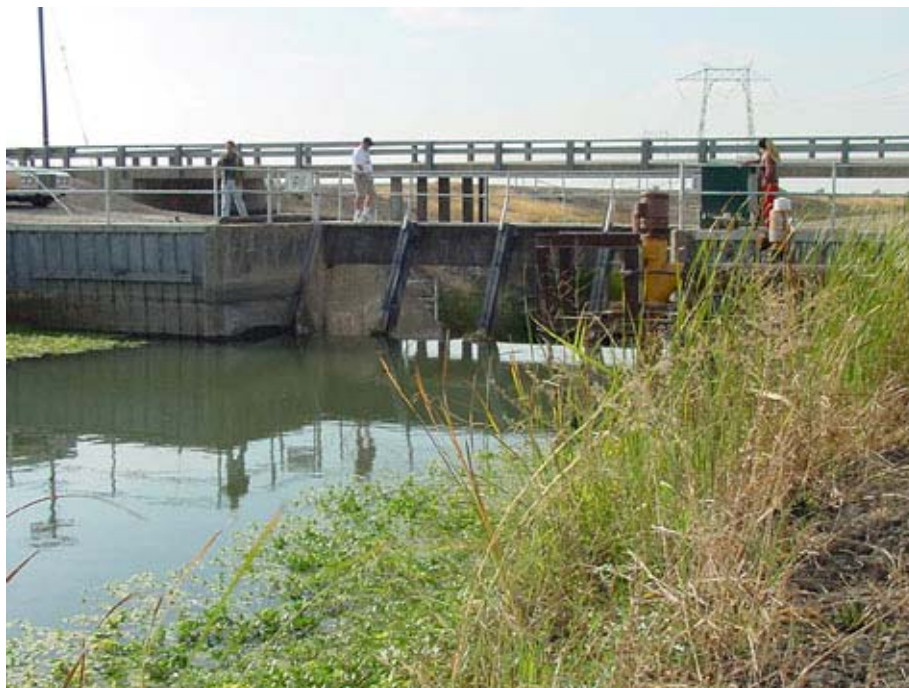
**Upstream side of structure from the left bank levee.**

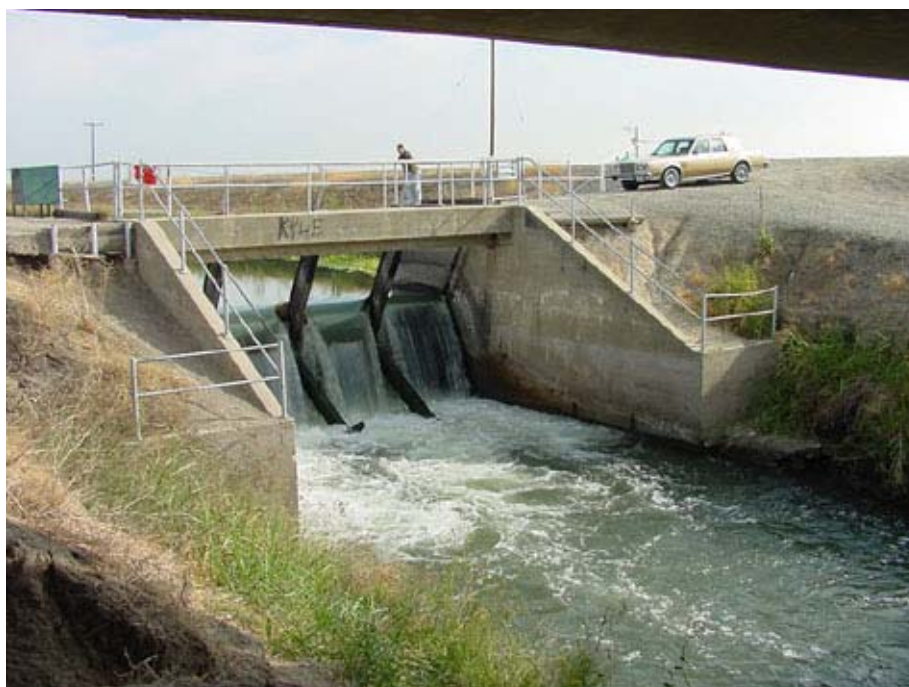
**Downstream side of structure from the left bank levee.**

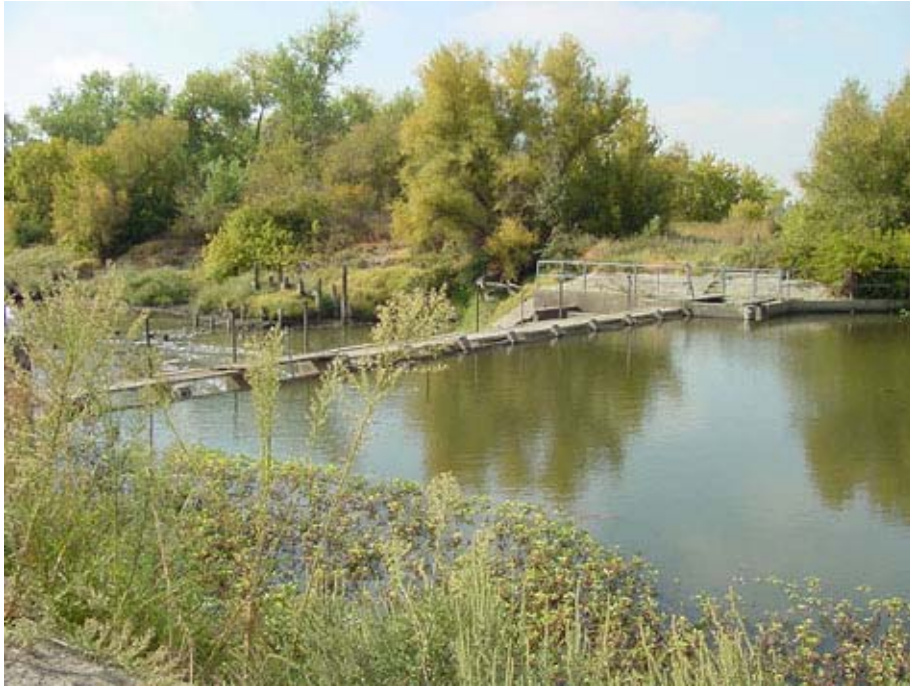
**Upstream side of the structure.**

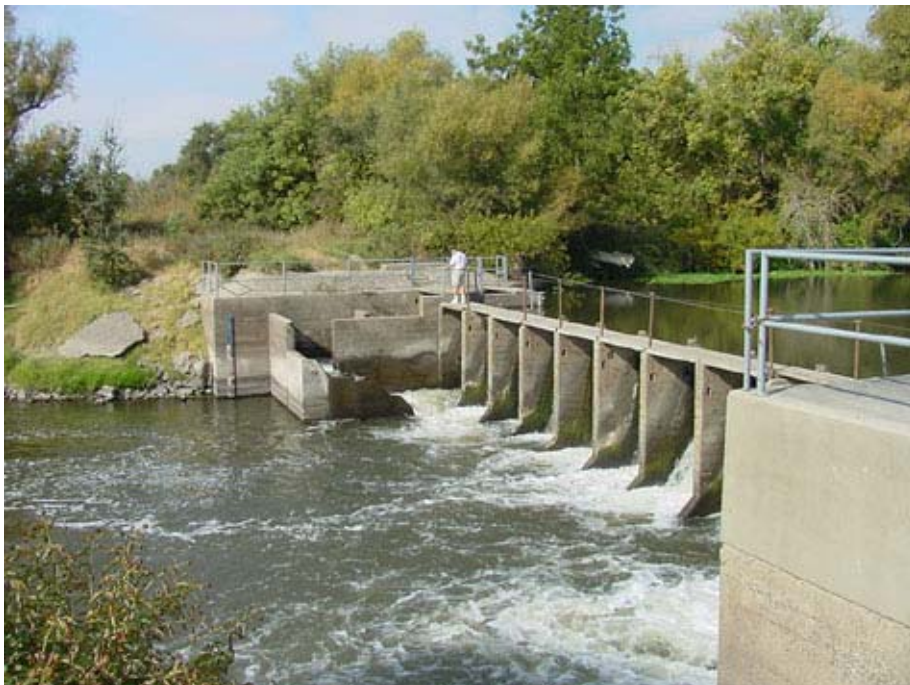
**Downstream side of the structure.**

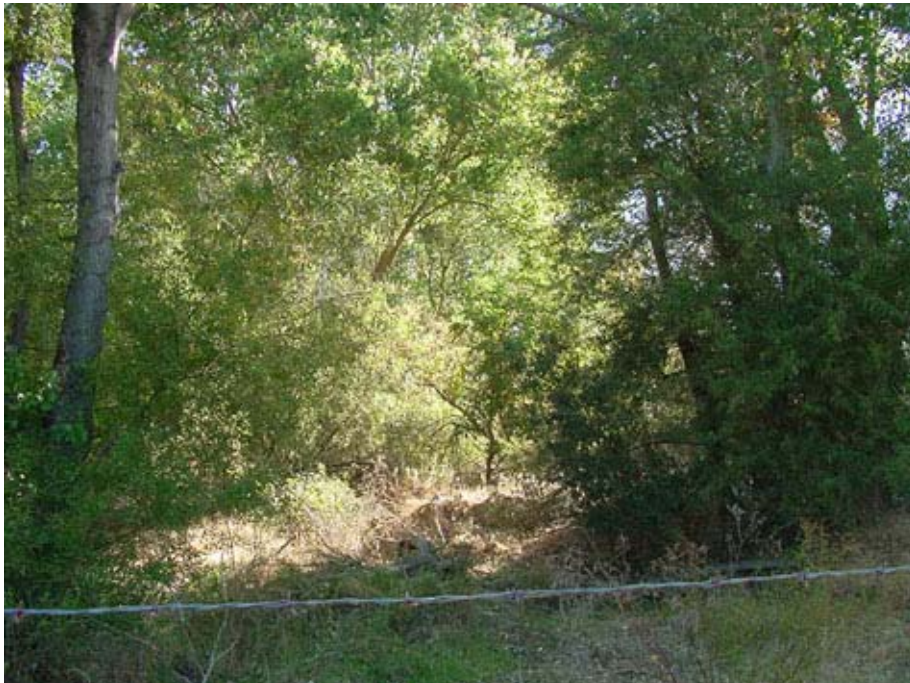
**Northeast from the southwest end of the weir.**

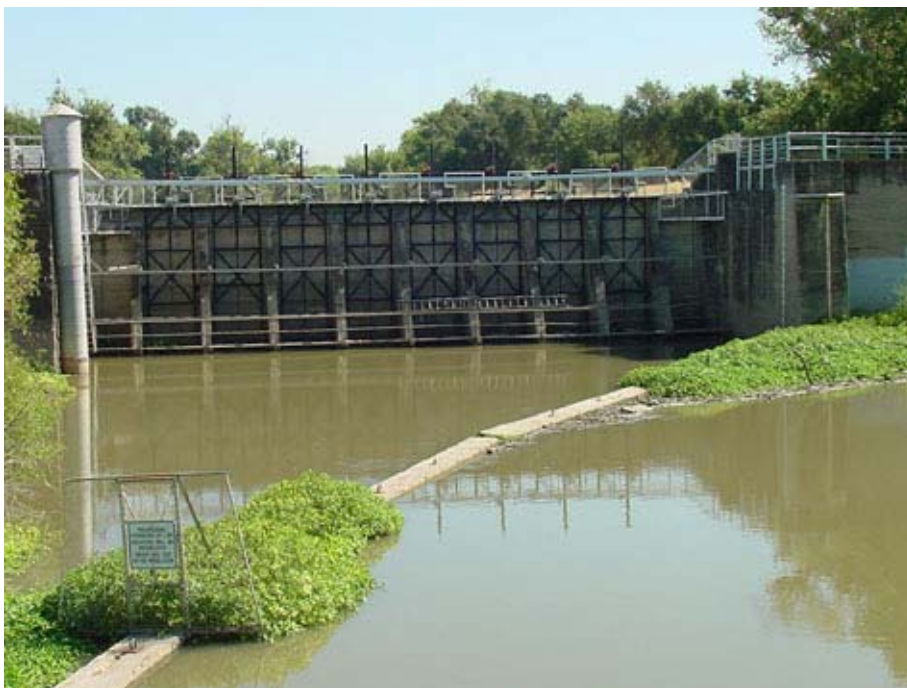
**Upstream side of structure from the left bank.**

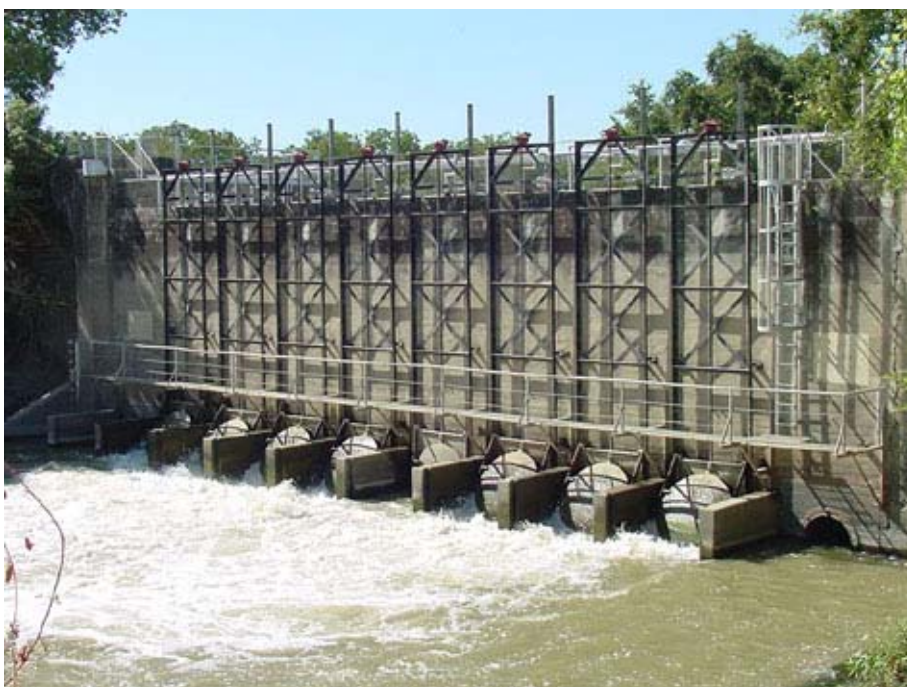
- 1. Condition of outfall structure.**
  - a. Good.**
- 2. Condition of bulkheads.**
  - a. Fair. The large vertical crack and displacement on the downstream side, left bank, has not changed in several years. The crack is not accessible for measurement, but the overall width is estimated to be 1 inch.**

**Downstream side of the structure from the left bank.**

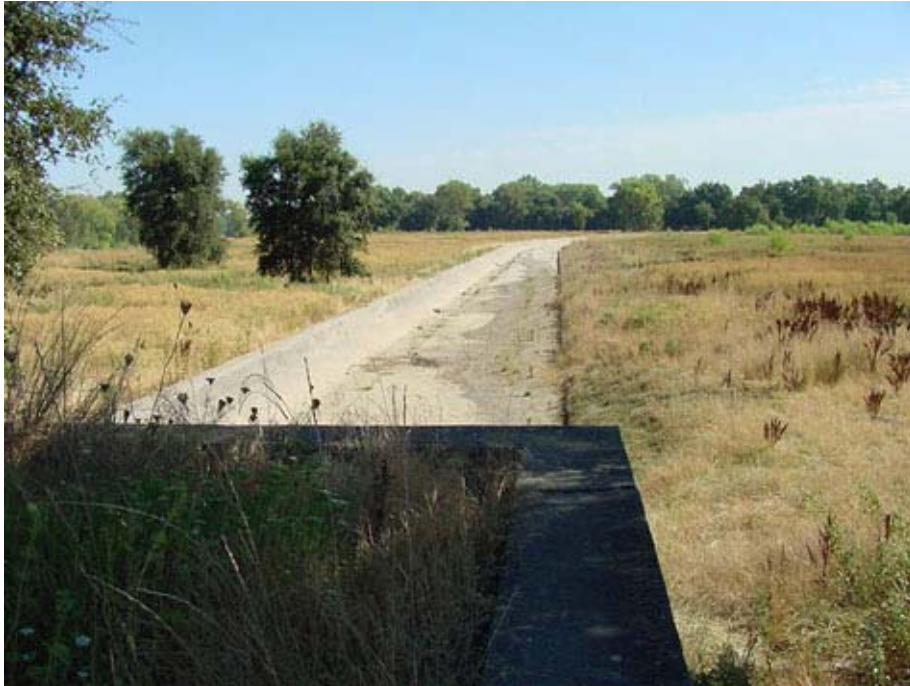
**Northwest at the weir and stilling basin from the north abutment.**

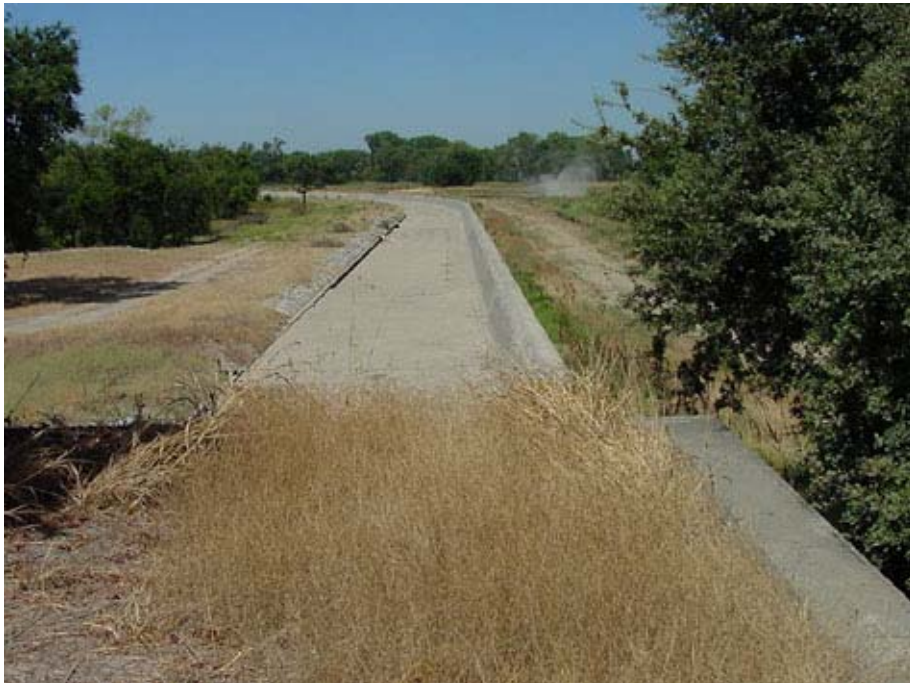
**North from the southern abutment.**

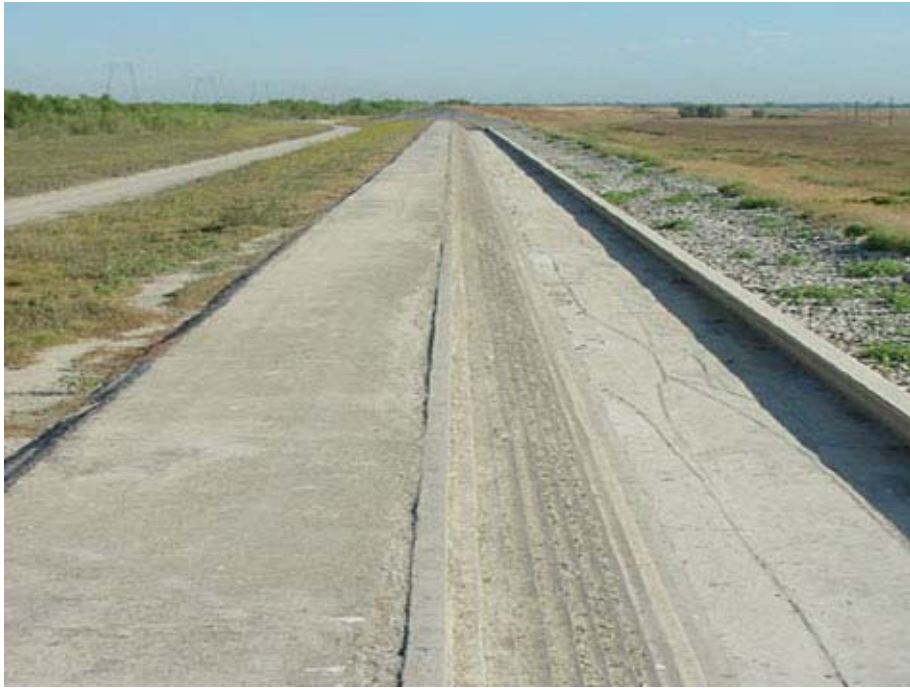
**East at the weir and stilling basin.  
The weir spills into the Yolo Bypass.**

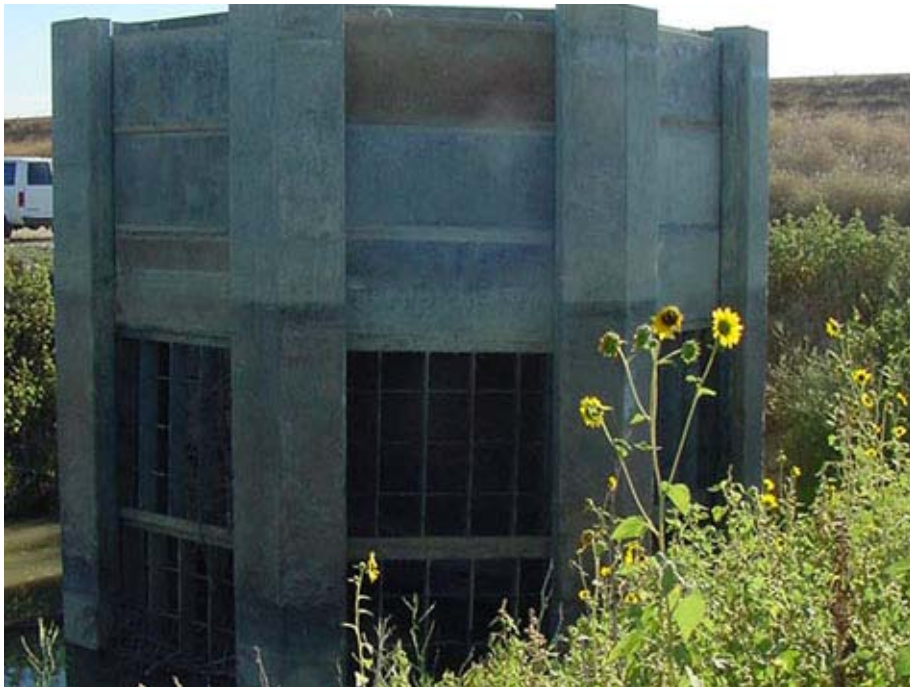
**View of the drainage structure located in the southwest  
corner of the Cache Creek Settling Basin.**

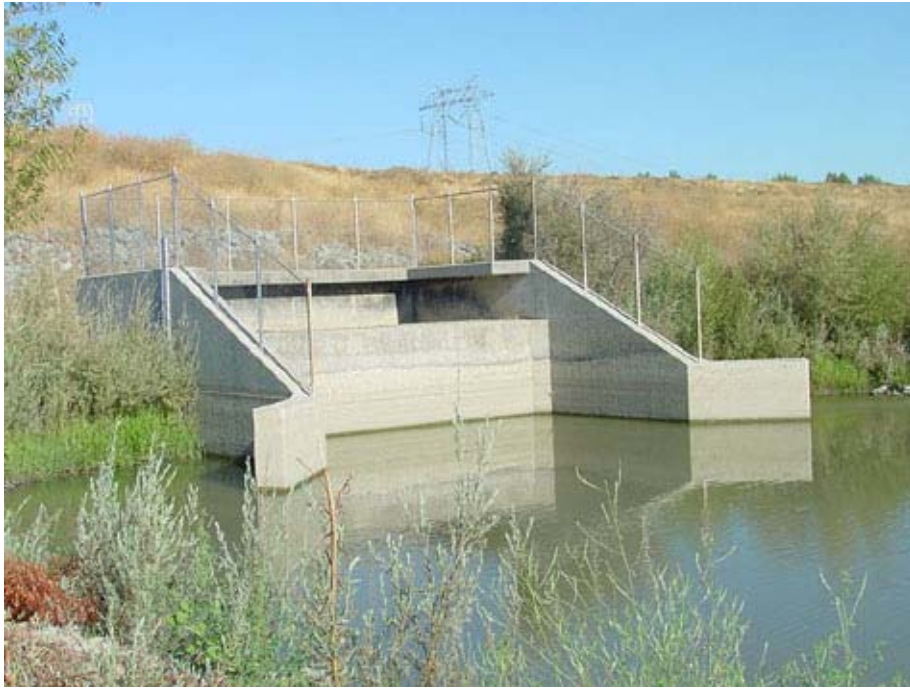
**West at the outlet drainage structure.**

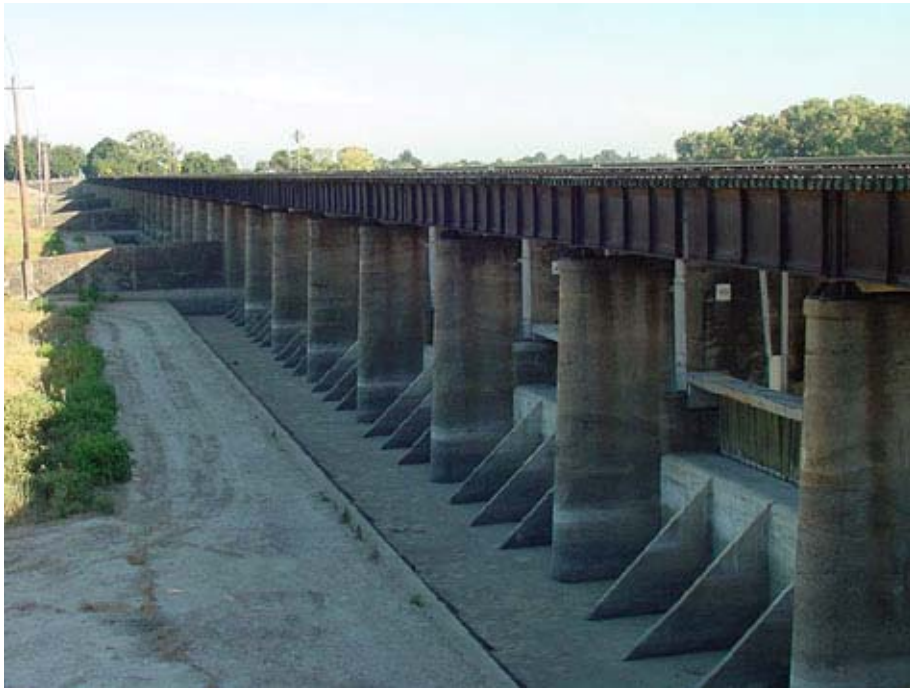
**Outlet side of the weir.**

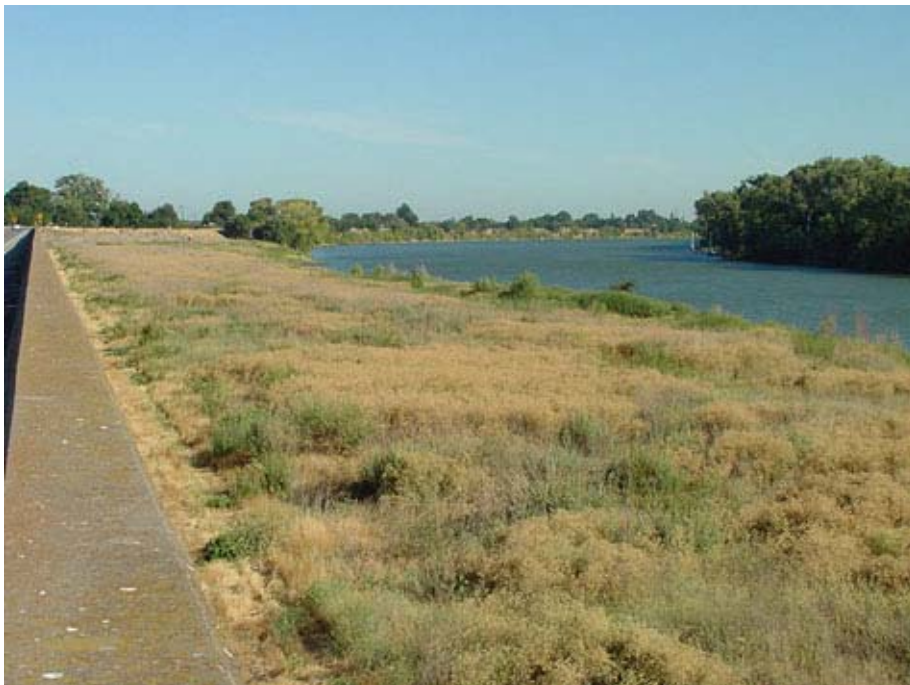
**Inlet side of the weir.**

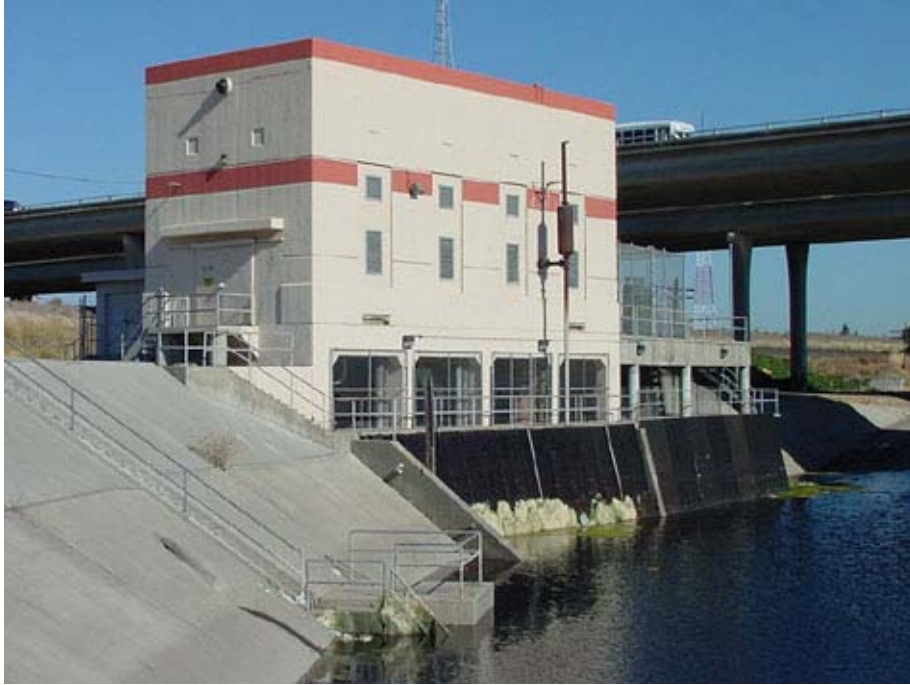
**Pumping plant, sump, and trash racks at inlet side on the landward side from the left bank levee of the Natomas East Main Drain.**

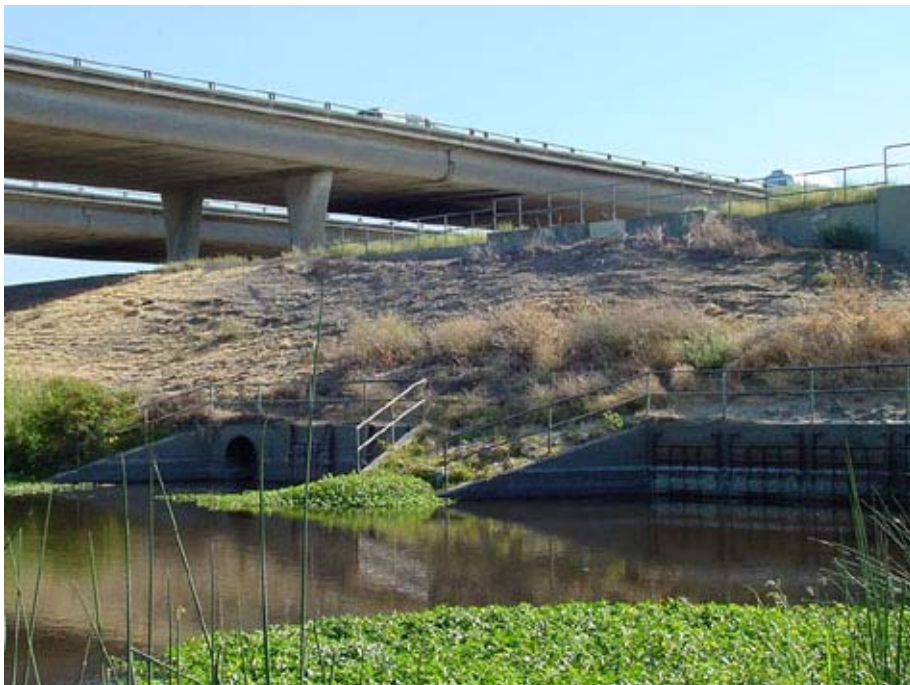
**Discharge end of structure on the water ward side from the left bank levee of the Natomas East Side Drain.**

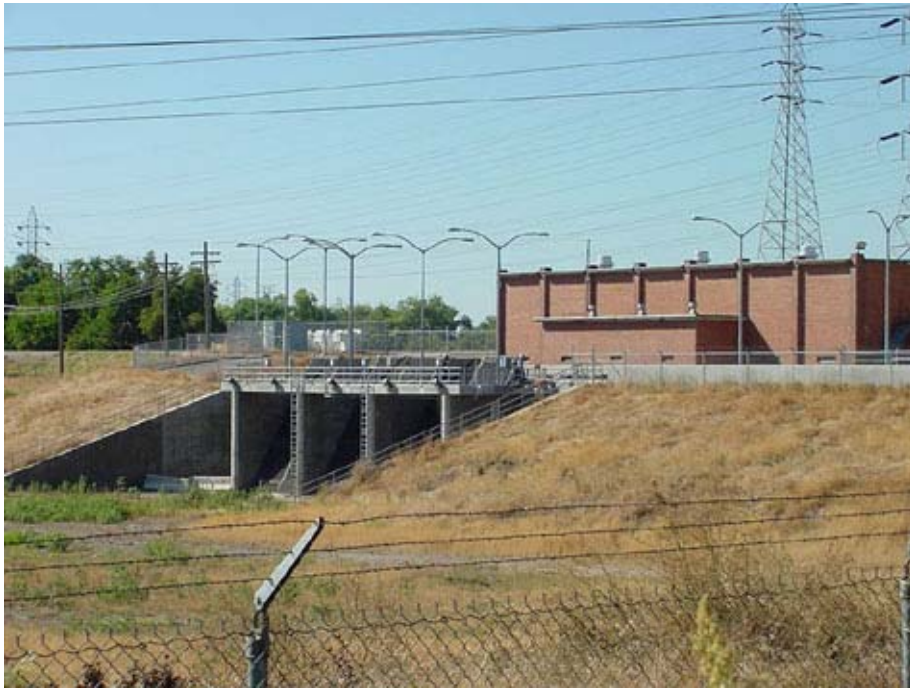
**Pumping plant, sump and trash racks at inlet on the landward side of the right bank levee of the American River.**

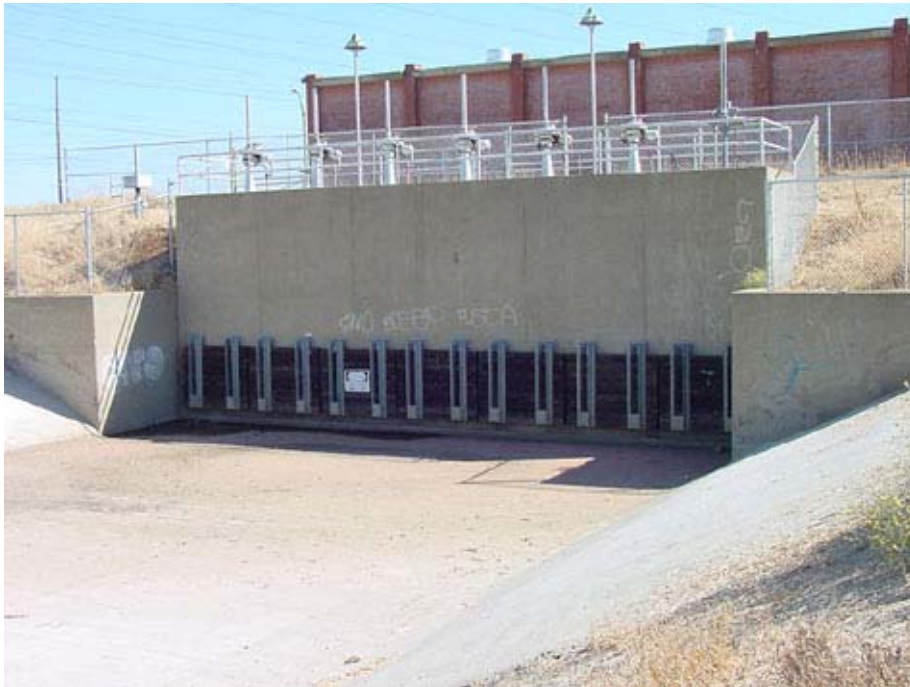
**Gate controls and gates at the discharge side of the pumping plant.**

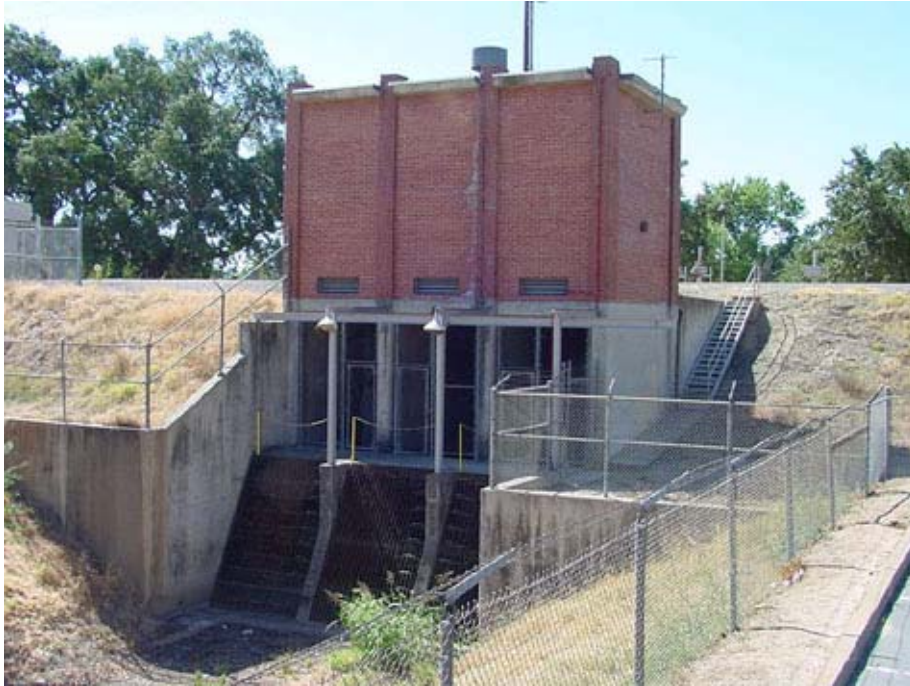
**Trash racks on the intake side of the pumping plant.**

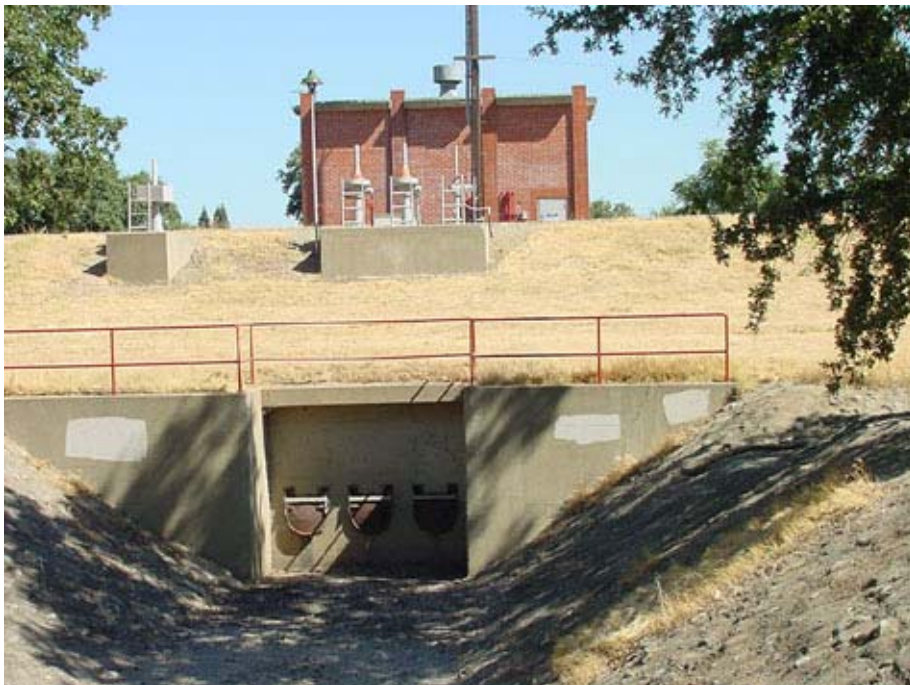
**Gate controls and flap gates on the  
discharge side of the pumping plant.**
